Leakage after fitting the oil filter insert in 1.6 and 2.0 TDI engines

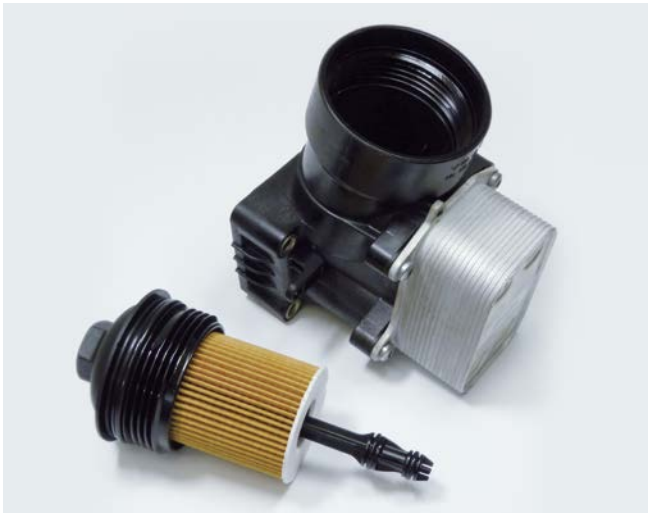
In diesel vehicles from the VW Group, the oil filter housing may leak in the engines indicated above following an oil change and the associated filter replacement. This can occur if excessive assembly torque is applied to the housing cover.

Figure 1: Oil filter module with oil filter insert

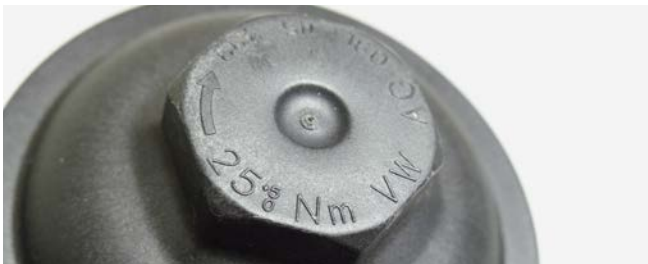
Figure 2: Torque specification on the housing cover

After the oil filter insert is changed, the cover is screwed back onto the housing; the permissible torque is **25 Nm** (+5 Nm).

Important! When changing the filter, always use a torque spanner to ensure compliance with the manufacturer's specifications. To prevent damage, coat the new gaskets with clean engine oil before fitting.

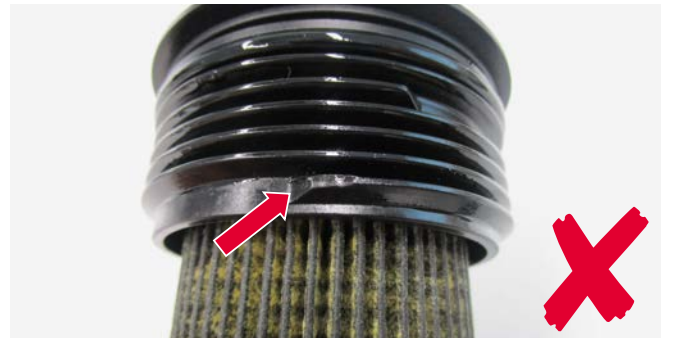
Figure 4: Damaged thread

If too much force is applied, this can damage the thread and warp the cover, resulting in leakage from the housing cover and loss of engine oil.
