Leakage after fitting the oil filter insert in 1.6 and 2.0 TDI engines

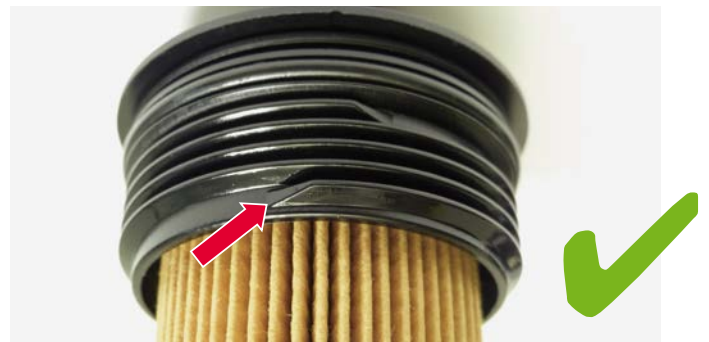
Figure 3: Undamaged thread

Important! When changing the filter, always use a torque spanner to ensure compliance with the manufacturer's specifications. To prevent damage, coat the new gaskets with clean engine oil before fitting.
